WHC REPORT 7649 14 June 1978

NAVAL WEAPONS HANDLING CENTER

PROTOTYPE CONTA NER MK 620 MOD Ø

HARPOON CONTROL SECTION,

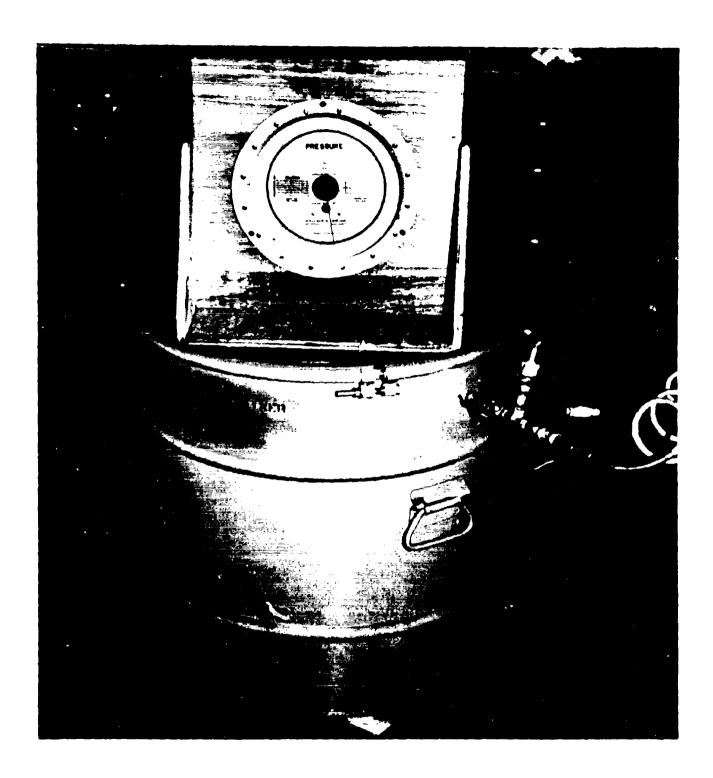
FIG. 5 LEAK TEST APPARATUS.

In preparation for the Leak Test, the container was fitted with an apparatus consisting of tubing, a shut off valve and an air pressure gage for determining the internal container pressure (Figure 5). An external source of compressed air was piped through the apparatus into the closed container. When the air pressure gage (Wallace and Tiernan, Model No. FA145) recorded the nominal specified container pressure of 2.5 psi, the external air supply was shut off. Air pressure corrections were made to compensate for temperature changes in the container before monitoring the leak rate.

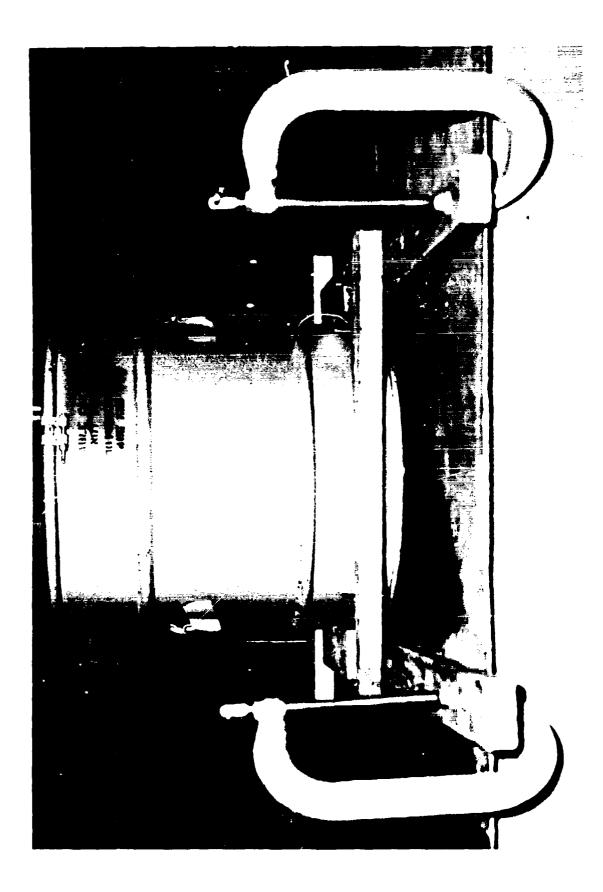
The loaded container was placed (base down) on a vibration table having a vertical linear motion of 1" double amplitude (Figure 6). The frequency of the table motion was increased until the container base left the table by 1/16" at some instant during each cycle. The container was vibrated for two hours under these conditions with an input vibrational shock frequency of 3.8 Hz.

Results - Post test examination disclosed no visible damage to either the HARPOON Boattail Section or container.

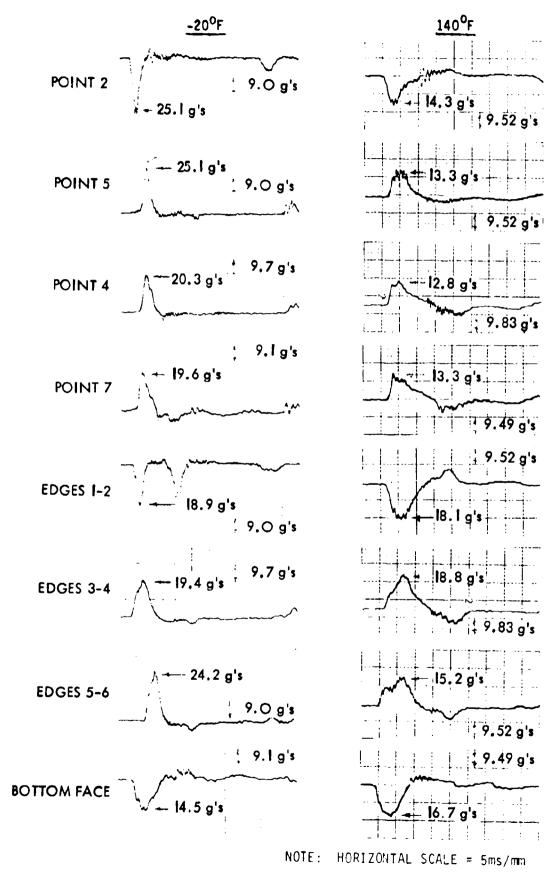
FIG. 7. MAJOR SHOCK PULSES.

- Results As generally expected from this test, the usual type of minor damage to the drum occurred as evidenced by slight indentations at the impacted locations. However, no detrimental effects to the container or Boattail Section resulted. The shock levels recorded at both specified temperature tests were within the parameters given in the Shock Spectra Envelope, Figure 1 of XAS 4315.

(See Appendix A.) The resultant beak shock (g's) are tabulated in Table II with the major deceleration-time curves shown in Figure 7.
- 8. Strength of Handles Test. Conducted in accordance with the requirements of Paragraph 4.17.2.1 of MIL-STD-648 and Specification XAS 4315.
- a. <u>Single Point Suspension</u>. The loaded container (96 pounds) was hoisted clear of the deck and held in the suspended condition for a duration of 5 minutes. Each handle was tested in this manner.
- b. <u>Double Point Suspension</u>. An overload weight of 384 pounds was added to the loaded container weight of 96 pounds and the entire
